PR/KBE/44659-001-Issue 1

**HARROGATE ROAD, WETHERBY
HYDROLOGICAL REBUTTAL REPORT**

HALLAM LAND MANAGEMENT LIMITED AND STOCKELD PARK

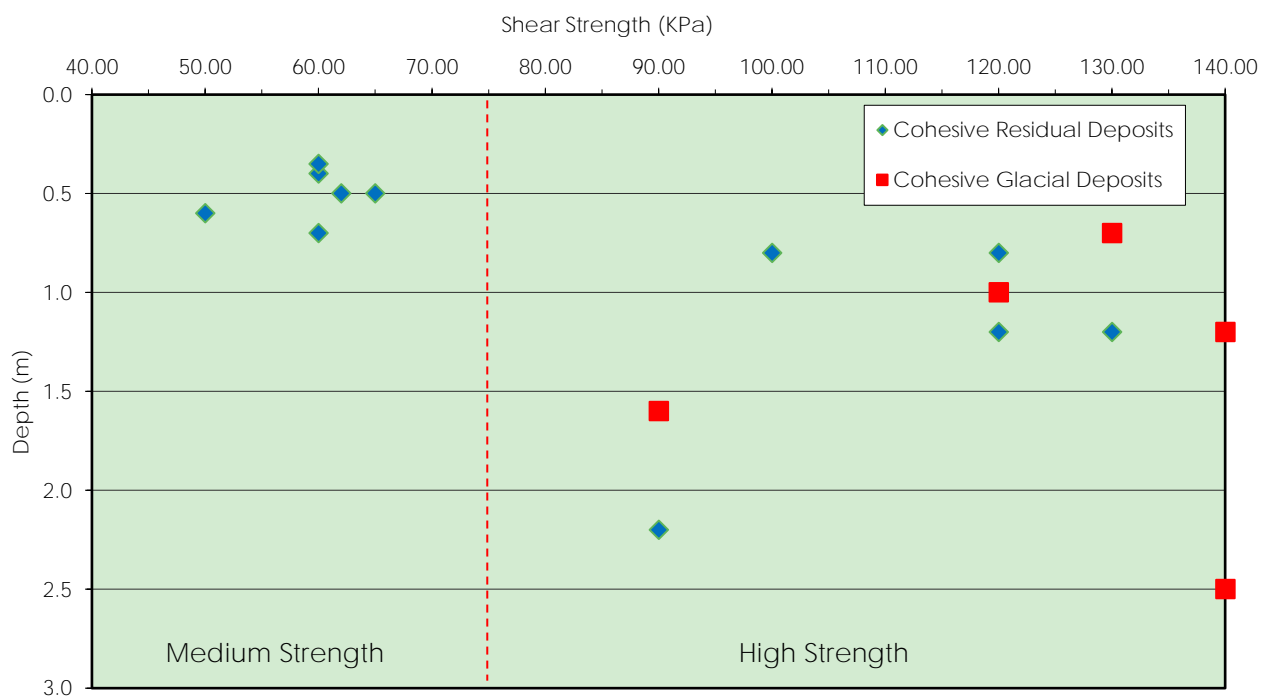
12.4.2 The results are summarised within the plot below and illustrate a linear increase in undrained shear strength (S_u) with depth within the cohesive deposits. Below approximately 0.5m depth S_u is typically greater than 60kPa (medium strength); all Cohesive Glacial Deposits are considered to be of high strength.

12.4.3 The plot below provides a summary of undrained shear strengths.

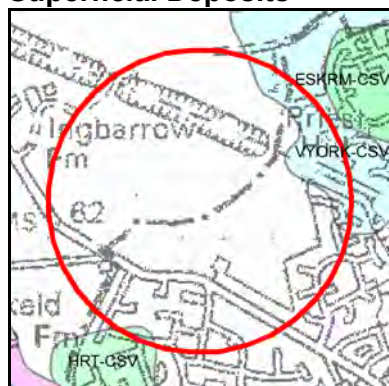
Superficial Deposits

The geological formations are listed broadly in order of age in the map keys (youngest first) but only to the formation level (a formation is a package of related rocks). Within formations, please be aware that individual members may not be ordered by age.

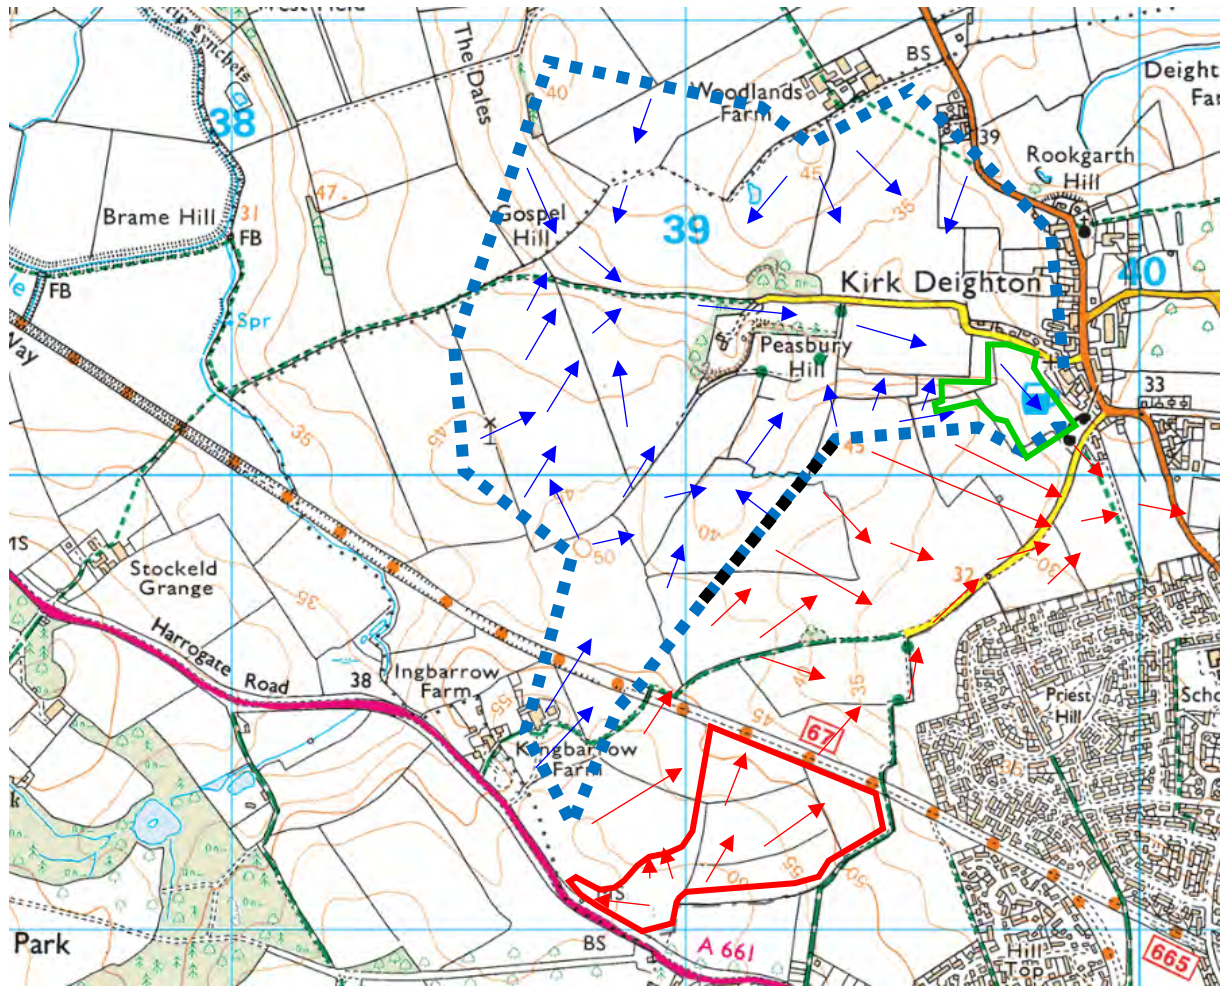
Extract OS plan showing indicative Kirk Deighton SSSI catchment

- ■ ■ Indicative SAC/SSSI catchment
- ■ ■ Watershed (ridgeline)
- Overland runoff flow path
- Proposed development
- SAC/SSSI

Surface water runoff from the proposed development can therefore be seen not to contribute to the surface catchment of the SAC / SSSI. It is also of note that while there will be a degree of infiltration within the soil, the clay content will promote surface runoff, particularly when saturated during times of more persistent rainfall, which is directed by the natural landscape away from the SAC / SSSI.

Item 3.6 – Geological maps indicate the north west end of the SAC / SSSI to be located on Mudstone and the remaining areas on Limestone. The ponds form in localised depressions in the ground following the low points in the area, hence the flood map similarity. Surface water will flow perpendicular to the contours until in a valley where it will flow parallel to equal gradient contours. Groundwater will predominantly follow the dip of the bedrock unless they encounter random fissures. Therefore, the geological catchment for the SAC / SSSI is north west of Kirk Deighton whilst the surface water runoff catchment of the SAC / SSSI is west of Kirk Deighton (Appendix 4).

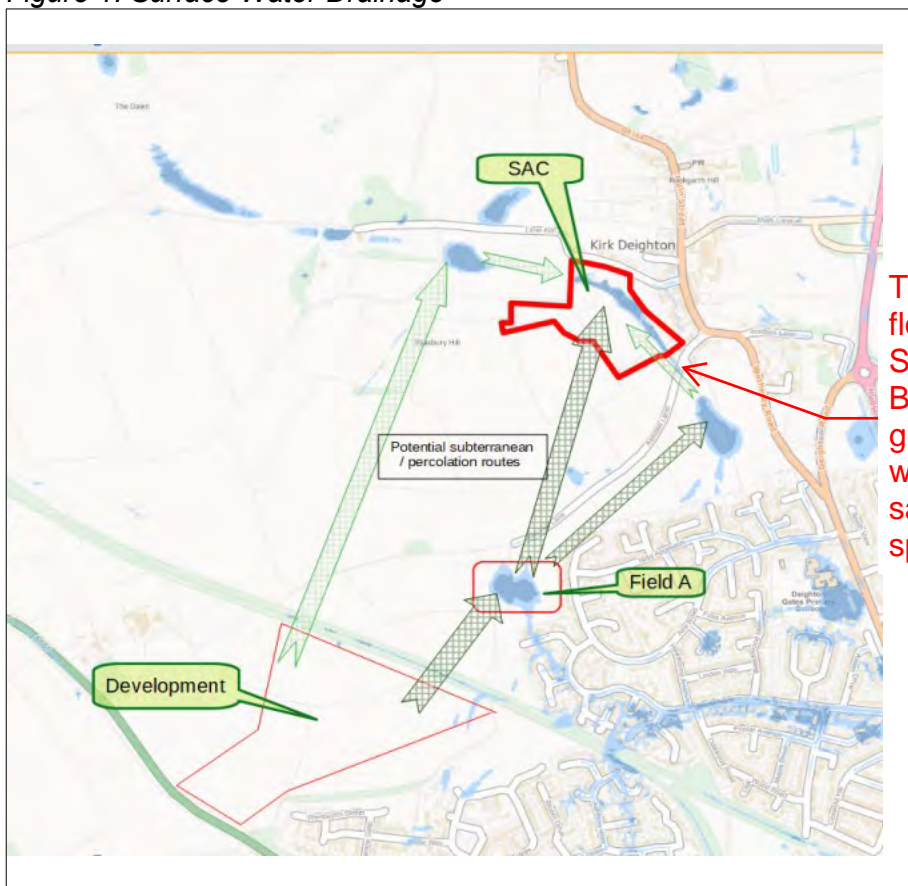
Figure 1: Surface Water Drainage

This indicates that water flows uphill towards the SAC/SSSI.
Below ground this implies ground water emergence, which BW Issue 3.6 has said does not occur (i.e. springs)

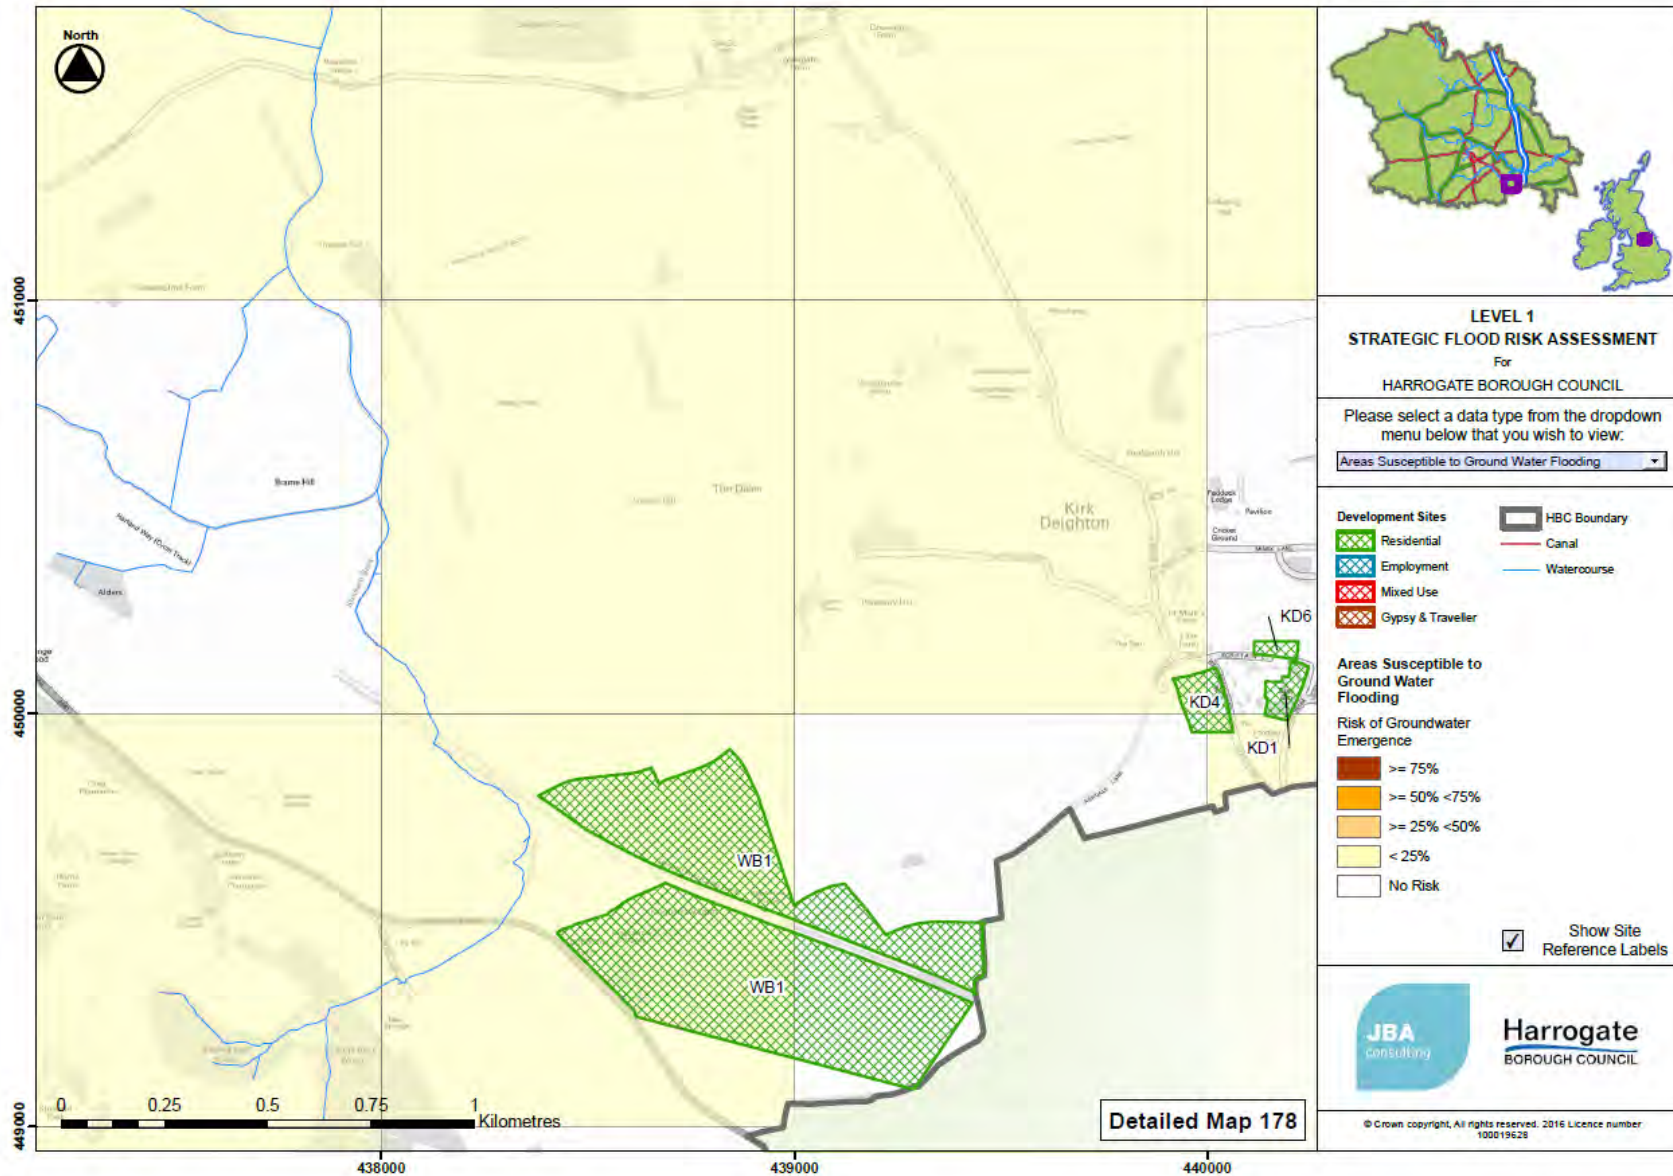
- 2.3 Appendix BWHy1 demonstrates that there has been a significant change in the drainage pattern in the area to the north of Harland Way adjacent to the Bellway (and proposed Hallam) developments. This has occurred since groundwork's started for the Bellway development thus indicating a strong causal link and supporting the proposed scheme in Figure 1.
